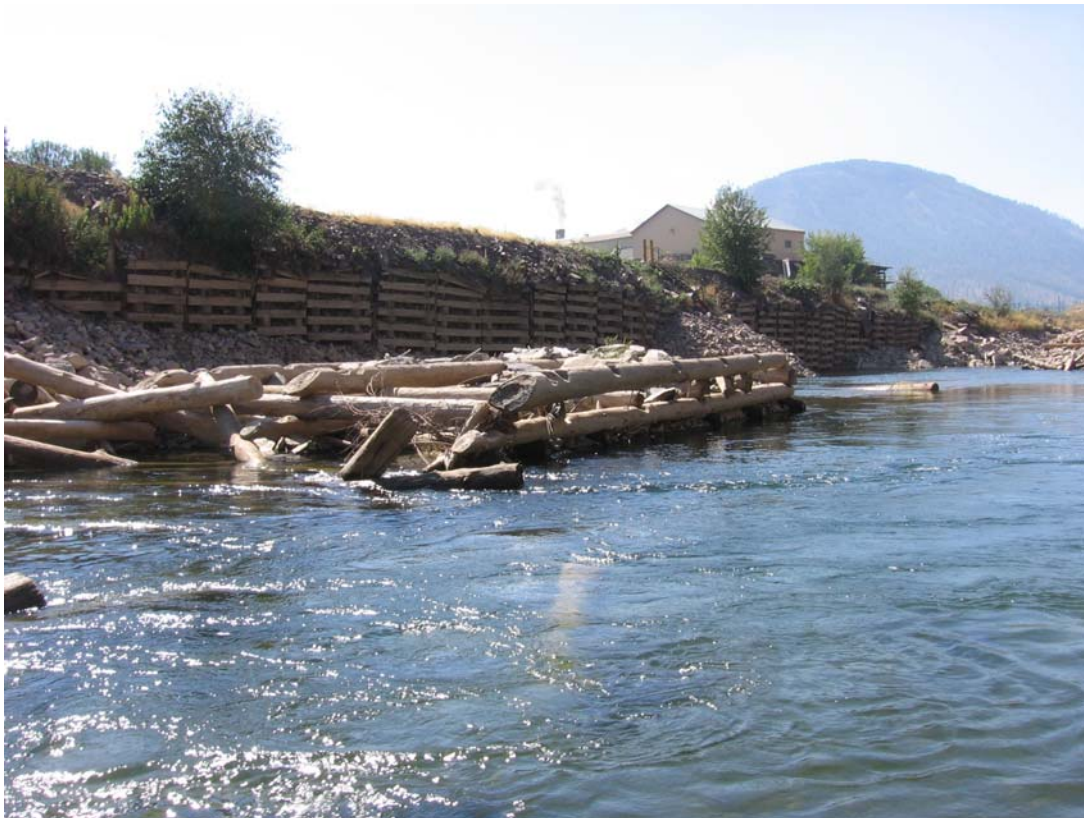
Photograph 1. View of cooling pond berm looking southwest showing wood cribbing within the berm.

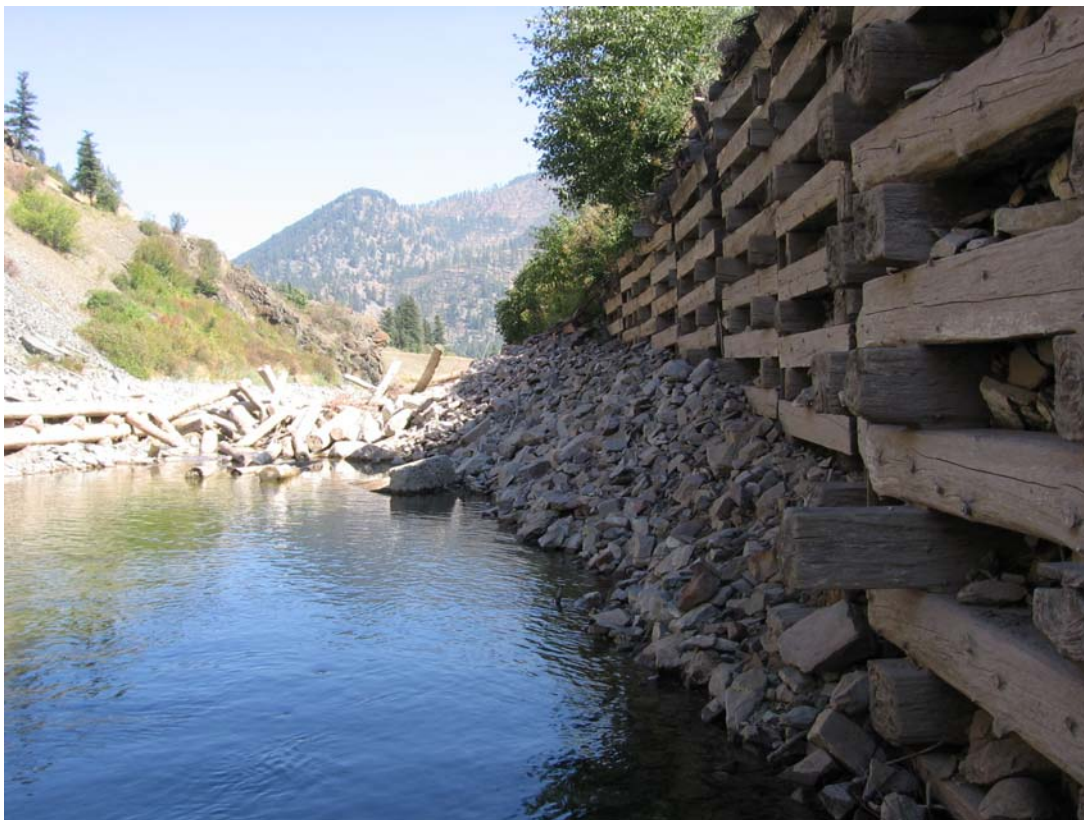
Photograph 2. Close up view of wood cribbing in cooling pond berm.

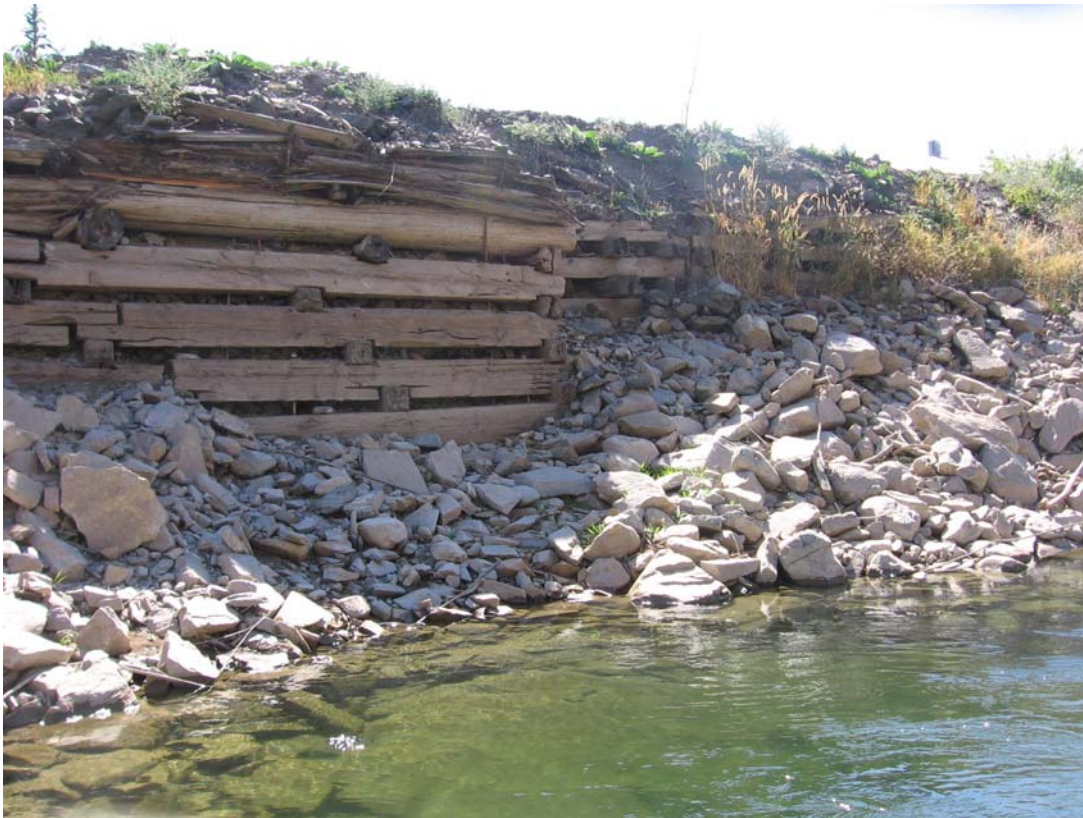
Photograph 3. View of wood cribbing in berm near the west end of the cooling pond.

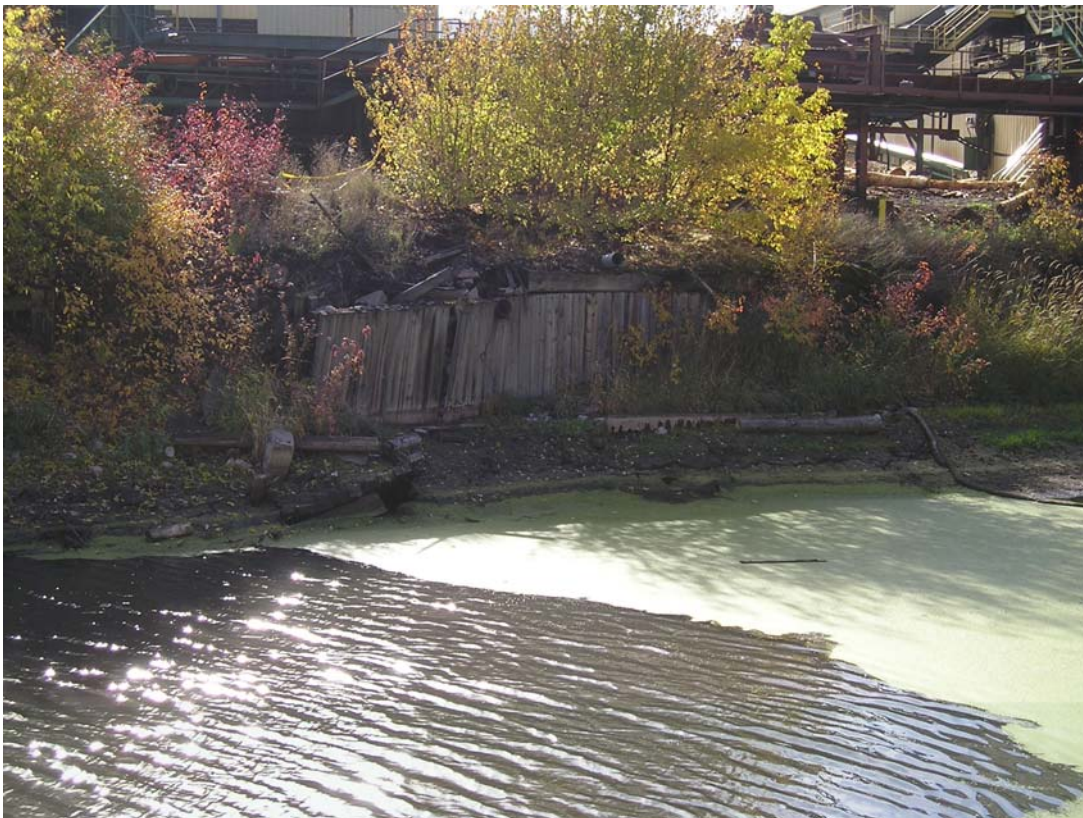
Photograph 4. Remnants of a wood retaining wall along a portion of the southern perimeter of the cooling pond.

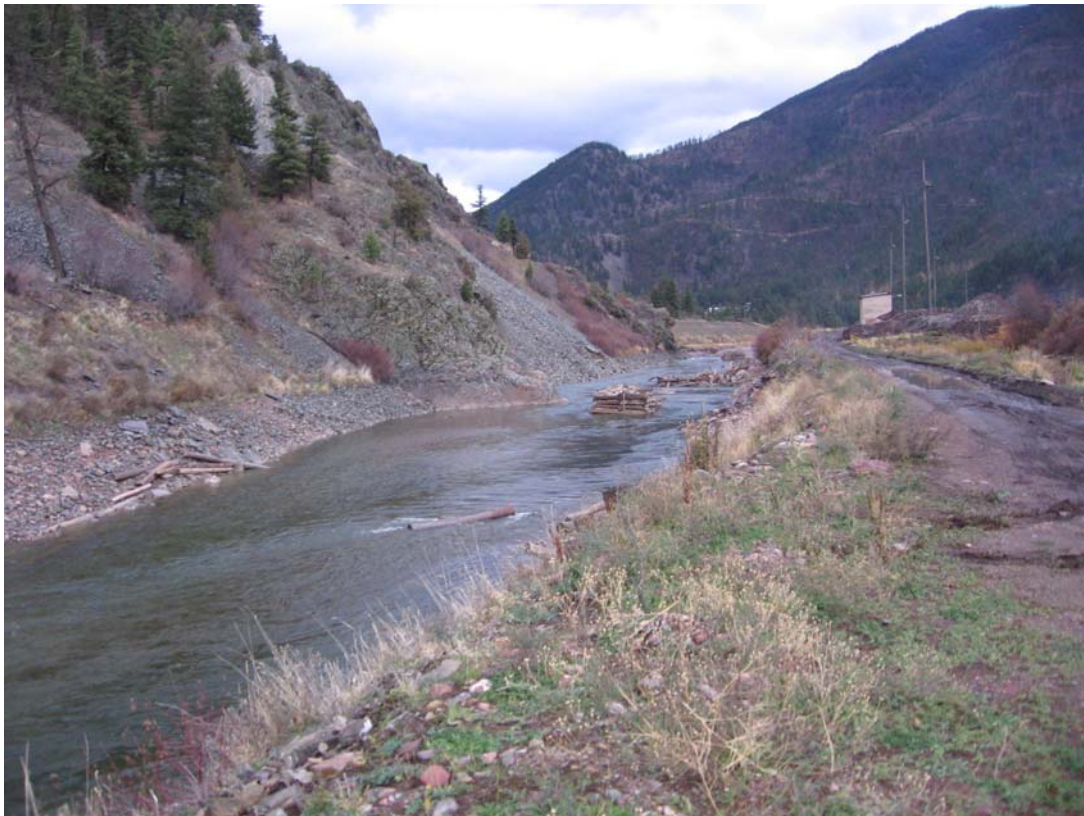
Photograph 5. View of the cooling pond berm looking east from the west end.

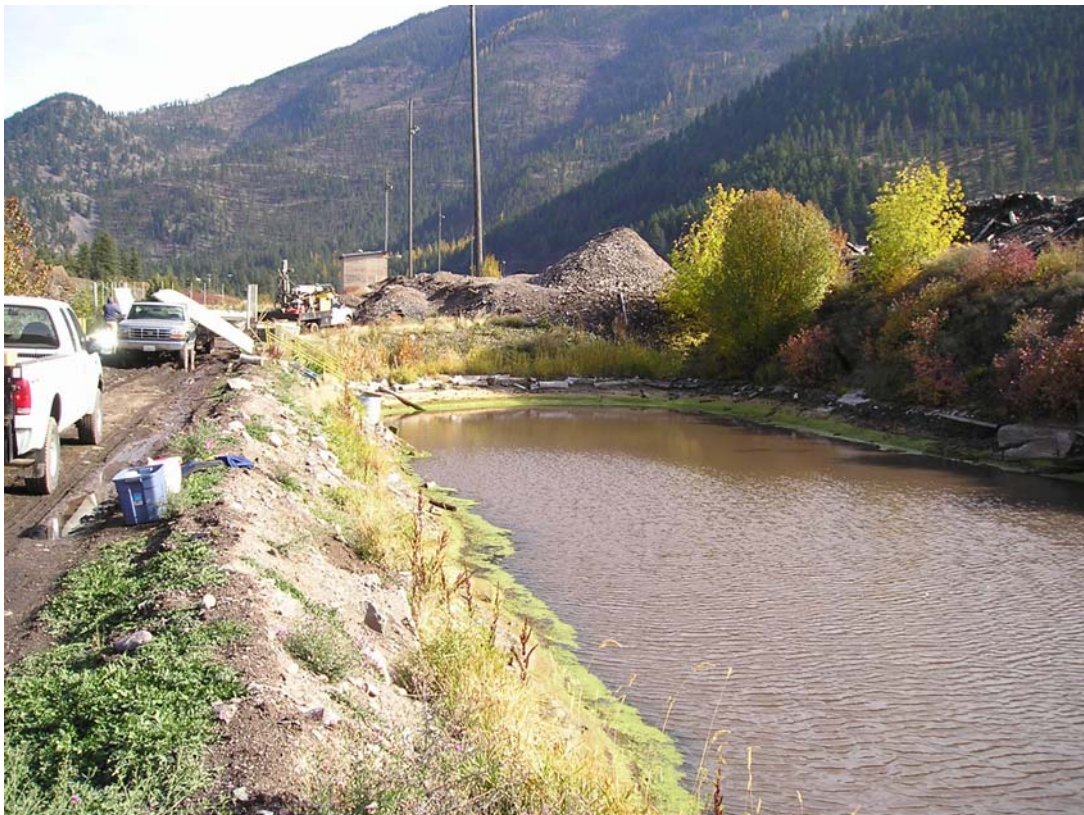
Photograph 6. View of the cooling pond showing the low water level. Note the outlet culvert in the northeast (upper left) corner of the pond.

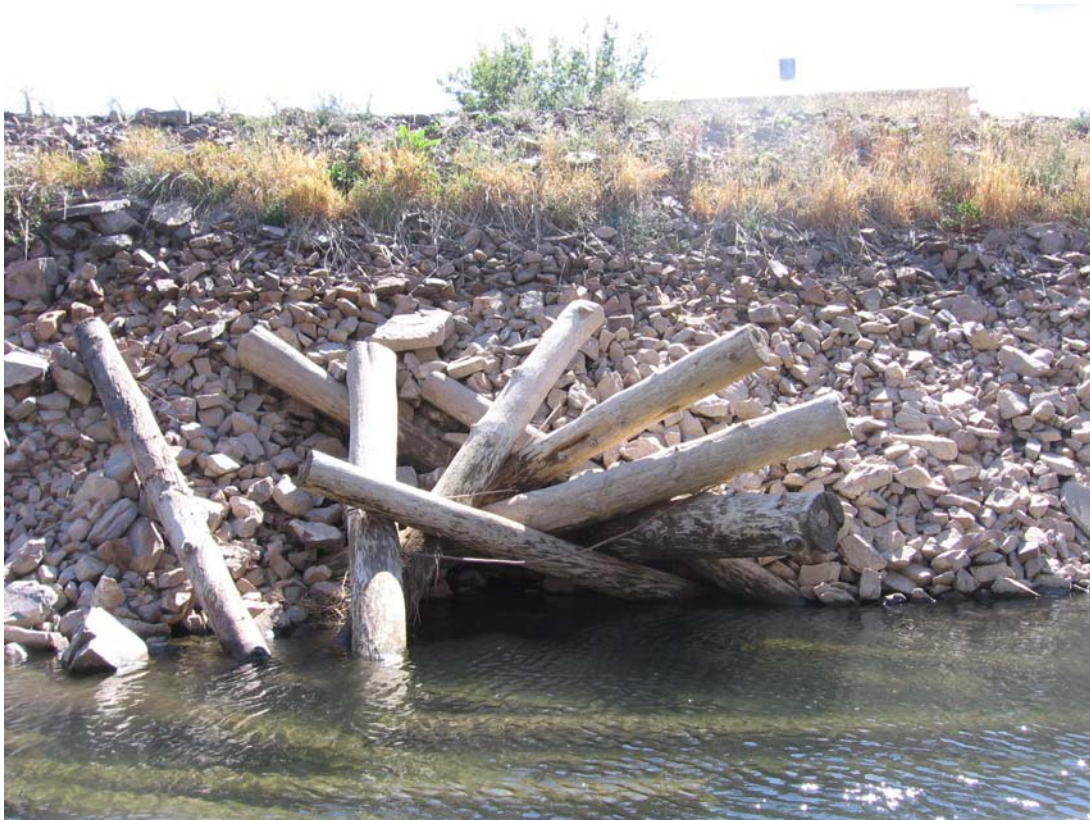
Photograph 7. Seep area on the berm near the west end of the cooling pond looking south. The seep discharges under the logs into the Blackfoot River.

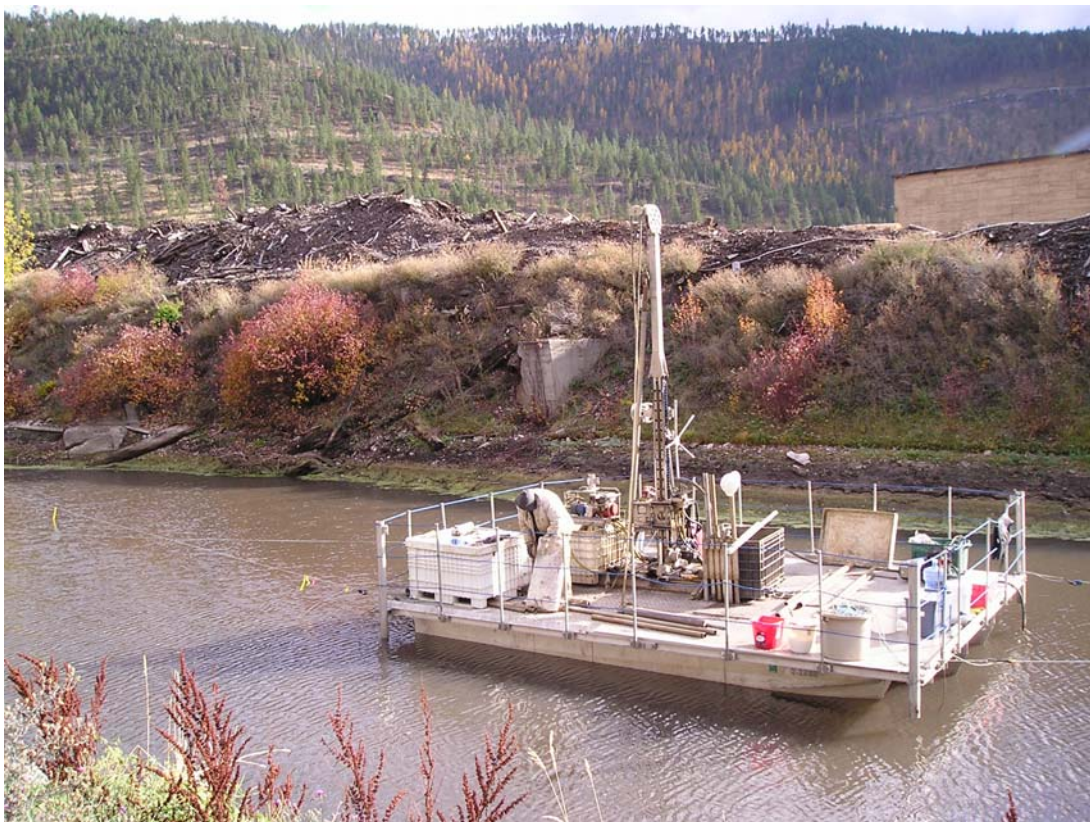
Photograph 8. View of drill rig and barge on the cooling pond.

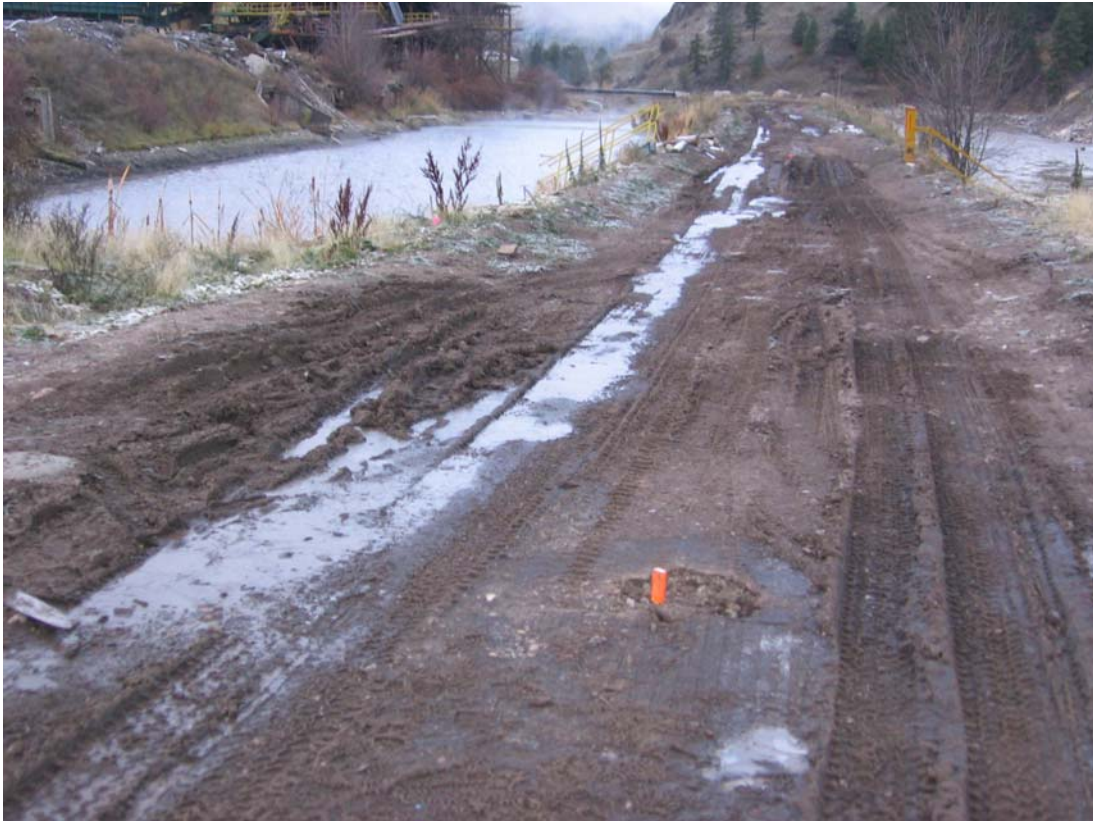
Photograph 9. View of the cooling pond berm looking west with the cooling pond on the south (left) and the Blackfoot River on the north (right).

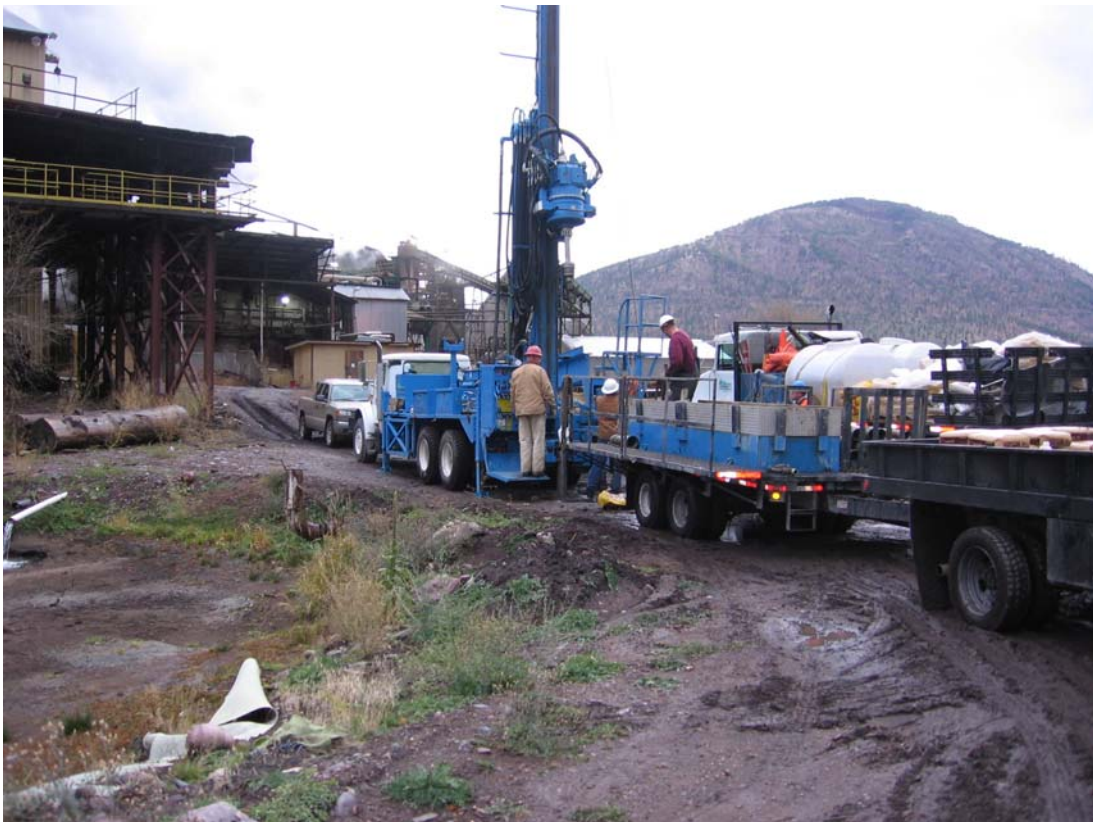
Photograph 10. Sonic drill rig at soil boring B-13 on the west end of the cooling pond berm.

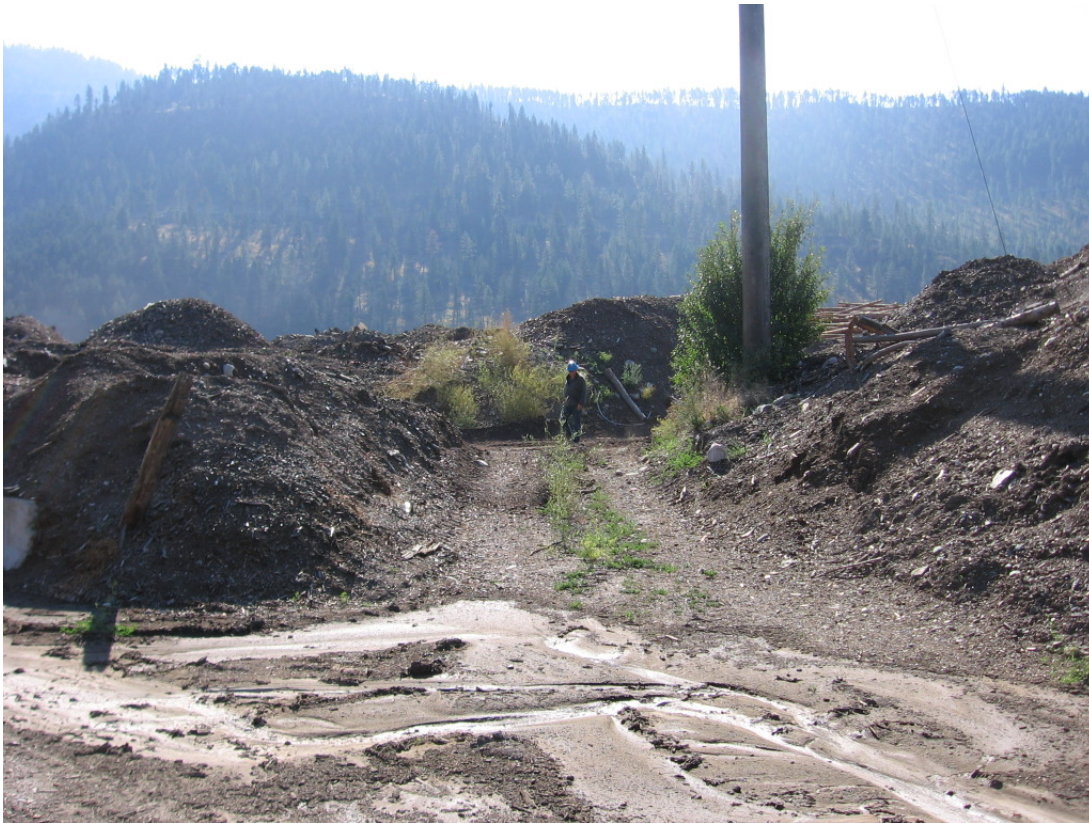
Photograph 11. Log yard waste piles east of the cooling pond.

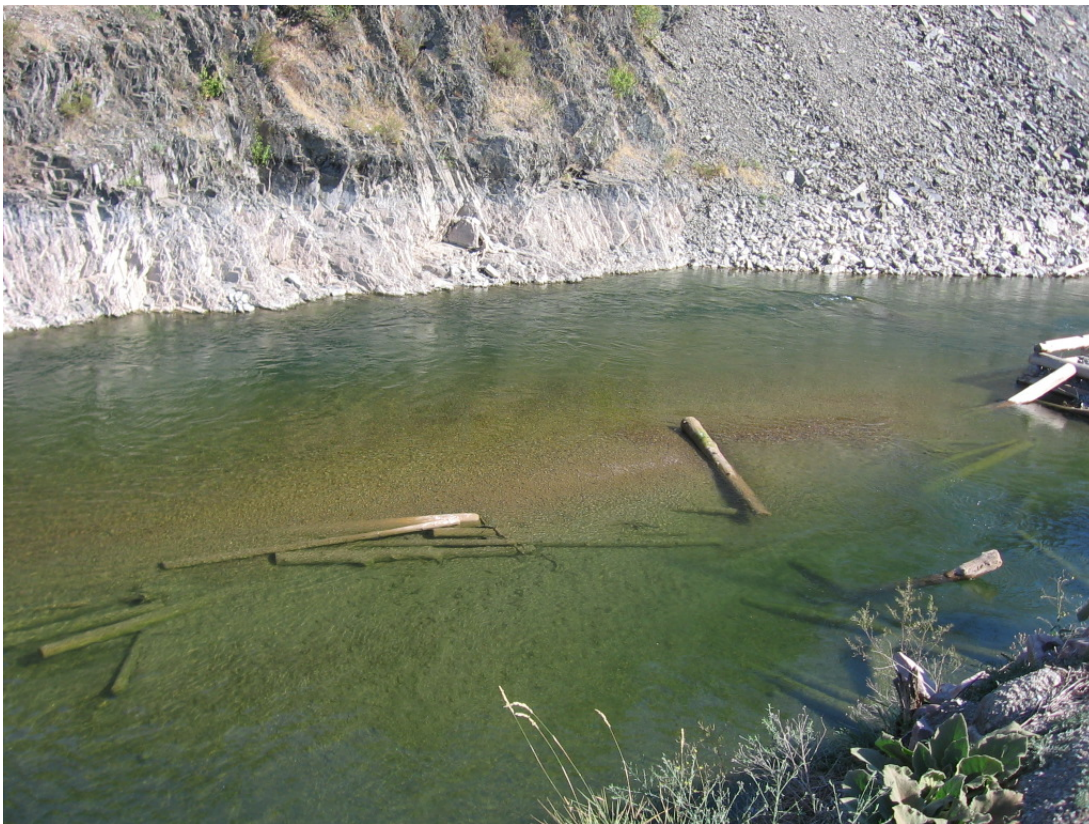
Photograph 12. Sunken log debris in the Blackfoot River.

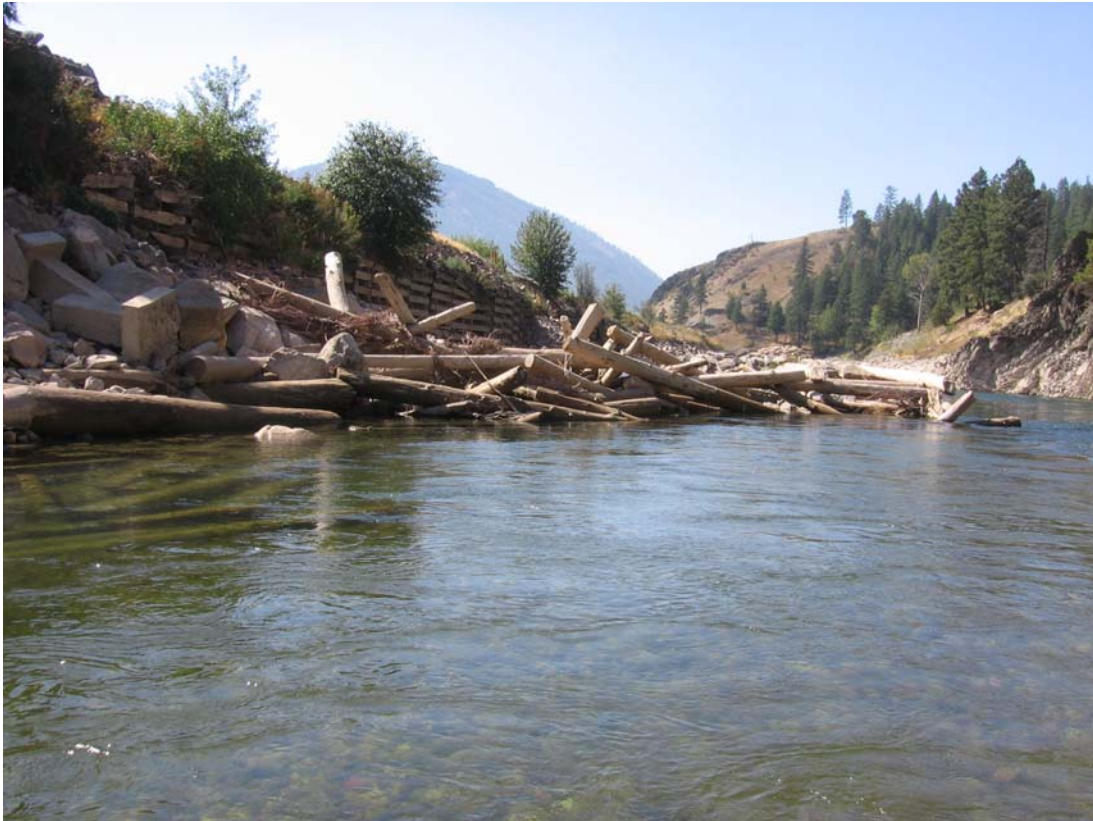
Photograph 13. Log debris in the Blackfoot River at the toe of the cooling pond berm looking west.

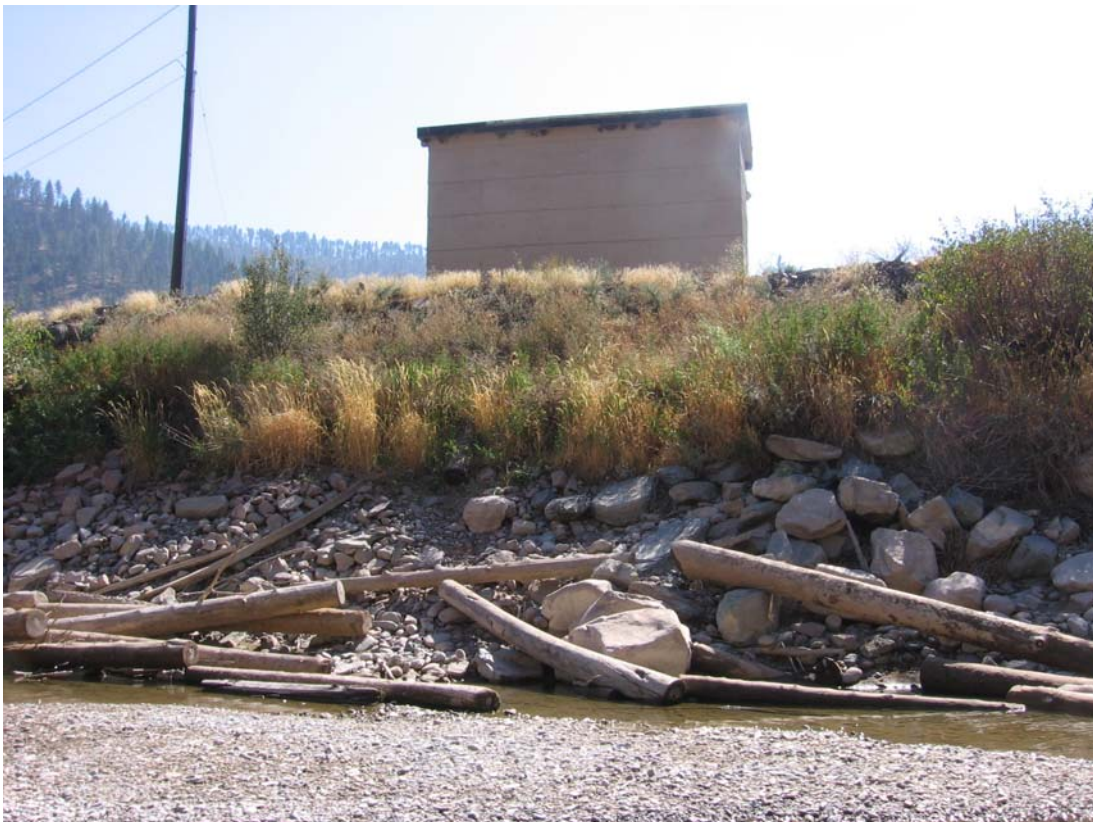
Photograph 14. Riprap, alluvium, logs and soil fill observed on the east end of the cooling pond berm.

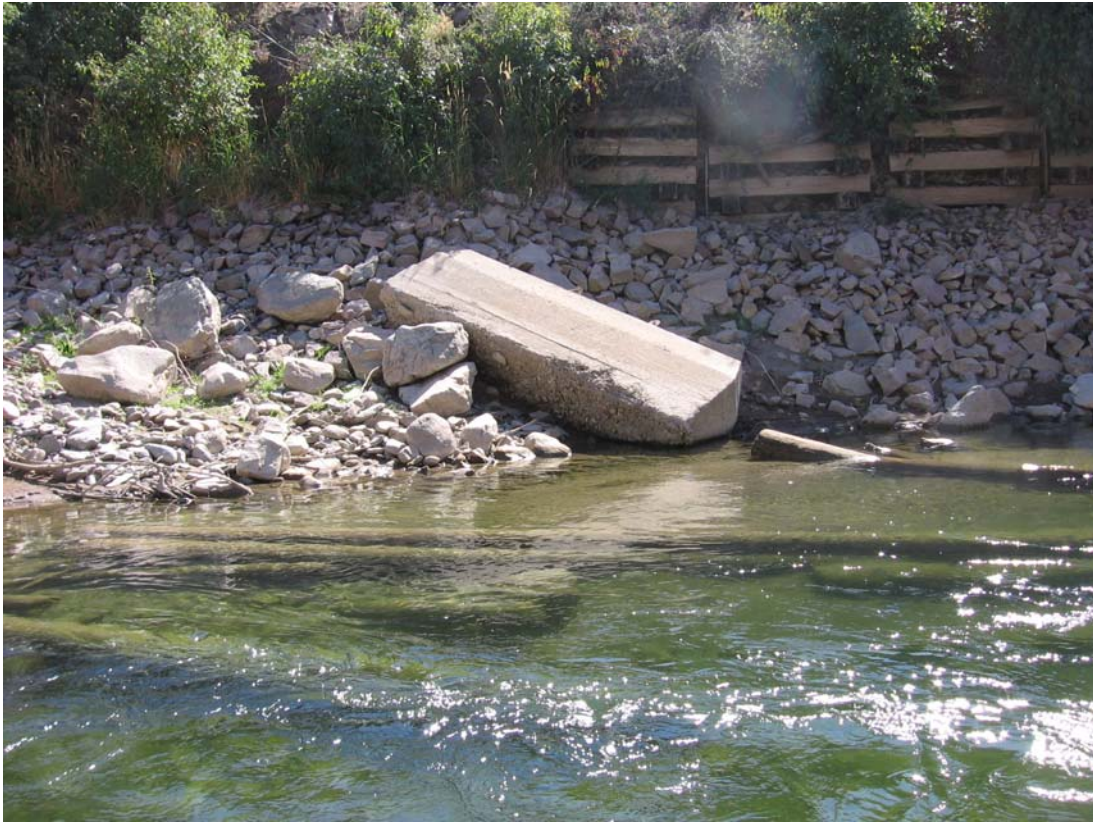
Photograph 15. Concrete debris on the edge of the cooling pond berm. Note the wood cribbing in the background.

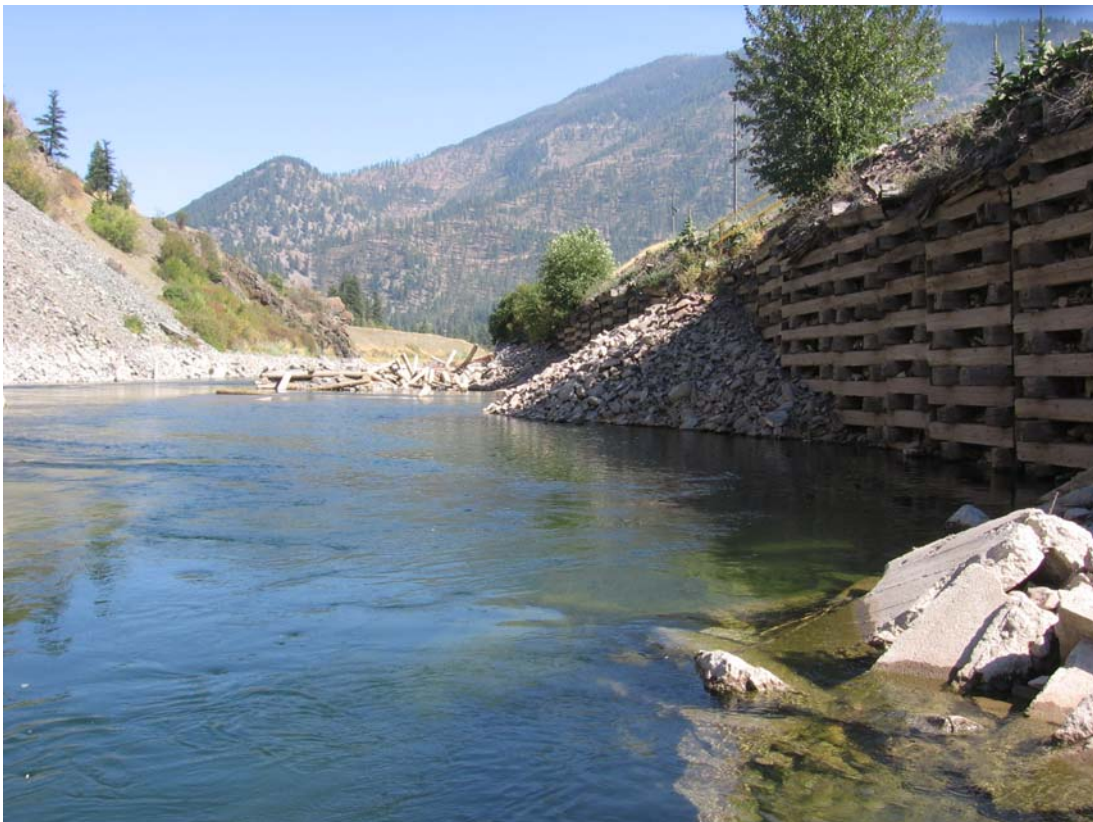
Photograph 16. Concrete debris (lower right) in the Blackfoot River at the edge of the berm. Note the wood cribbing (upper right) and wood debris (background).
